# Pedestrian-Bicycle Transition Plan

## Chapter 2

# Inventory & Self-Evaluation

OCTOBER 2005

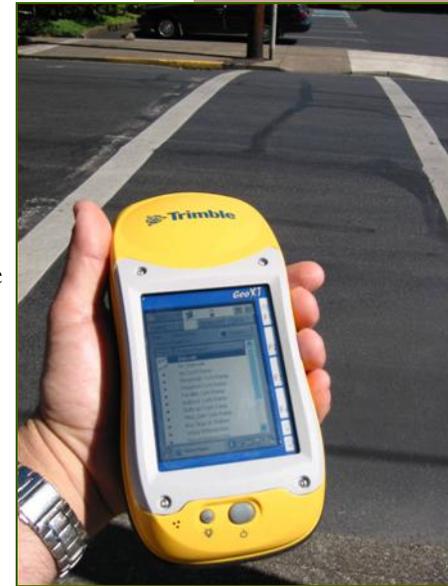
A number of GPS products were considered. It was decided that the *Trimble GeoXT*

provided ACHD with the best hardware and software product to (1) quickly develop and deploy a detailed data collection routine that addresses critical system components, (2) record field data with very high geo-positioning accuracy, and (3) quickly learn and adapt ACHD's data collection capabilities for a variety of agency needs.

The GeoXT's units were equipped with *Terrasync* software for maximum data collection capacity and geospatial GPS accuracy. The *Pathfinder Office* software provided ACHD the ability to efficiently develop the sidewalk/curb ramp inventory template, called a "Data Dictionary," accurately transfer files between desktop computers and the GeoXT units, and accurately *correct* raw data for higher GPS accuracy – a process known as *differential correction*. Once the field data was transferred and geo-corrected, Pathfinder Office also provided routines to convert the raw data into geographic information system (GIS) coverage files. Following the raw data conversion, ACHD was then able to assimilate the sidewalk/curb ramp data with other GIS data in its

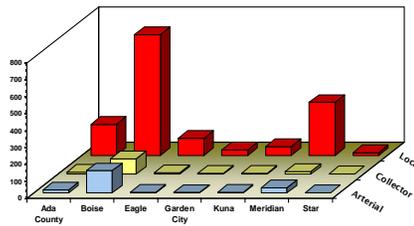
*Sidewalk Location: By Jurisdiction & Street Class*

Local streets constitute a predominant share of the total street mileage within the study area. Most of the existing sidewalks are located along local streets. By far, the Boise city area of impact is where most sidewalks are located. However, the Meridian city area of

impact also includes a large portion of existing sidewalks within Ada County. Many of the sidewalks in Meridian are relatively new, as Meridian is the location of a large portion of new development in recent years.

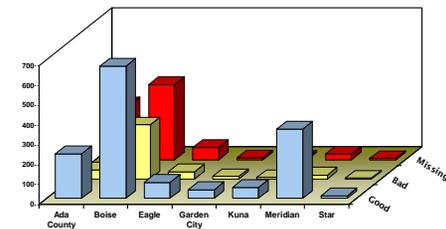
*Sidewalk Condition By Jurisdiction*

A cursory examination of the sidewalk inventory was undertaken to identify location of sidewalks that likely needed to be replaced (due to significant heaving/cracking

or non-compliant width) or missing sidewalks, by city area of impact.

Again, the older developed areas have a larger portion of older sidewalks needing repair or new sidewalks. In some cases these areas were developed prior to the current sidewalk design standards and/or site development standards that required sidewalks to be built on both sides of the street. Older Boise neighborhoods are the subject area with a larger number of missing sidewalks and sidewalks in poor condition.

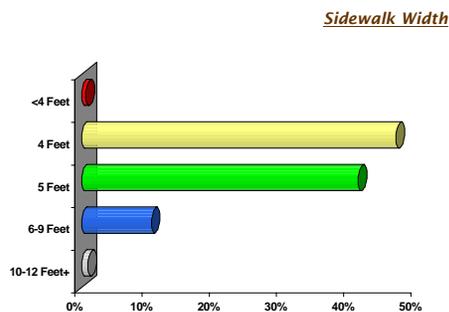
Most of the study area existing sidewalks are at least four feet wide. Many sidewalks are five feet or wider. Only a small percentage of existing sidewalks are less than four feet wide. Not all of the existing sidewalks are free of obstacles that reduce the effective clear width (minimum of four feet), but the fact that the majority of existing sidewalks are at least four feet or wider is an excellent starting point of the Transition Plan.

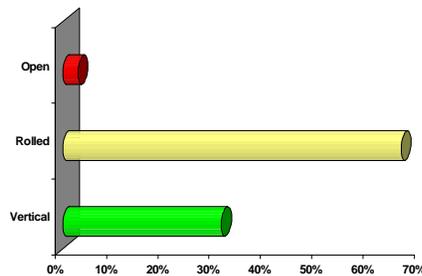
Curb Type

On a ratio of about 2 to 1, rolled curbs are the predominant curb type along streets with sidewalks. Vertical curbs are more often found in older neighborhoods and along arterial streets. Rolled curbs appear to be the design of choice for neighborhood streets over the past 10-20 years (see *Local Design Guide*).

Where sidewalks are present, only a small portion of the adjacent streets are absent of some type of curb within the study area.

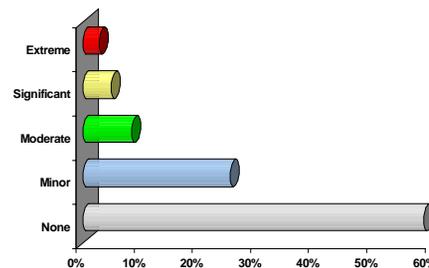
Heaving and Cracking

Sidewalks with significant heaving and cracking can be problematic for pedestrians with limited mobility. Only a small portion of the study area sidewalks have significant or extreme heaving and cracking conditions. Most of these sidewalks are located within older neighborhoods – sidewalks that are fairly old and impacted by significant tree growth and/or deterioration. The majority of the existing sidewalk system in Ada County has little or no heaving and cracking conditions.

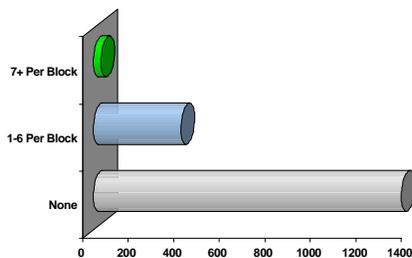
*Miles of Sidewalks with Fixed Obstacles—Density*

The inventory program was developed specifically to identify the location, type and density of fixed and removable obstacles found along existing sidewalks. The majority of existing sidewalks do not have fixed obstacles that reduce the pedestrian clear width of four feet. Those sidewalks with fixed obstacles, the number of obstacles are usually less than seven per street block.

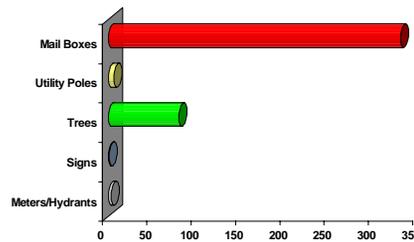
*Miles of Sidewalks with Fixed Obstacles—Type*

be relatively easy and inexpensive to move or remove. Review of the data indicates that mailboxes are the predominant type of fixed obstacle that reduces the sidewalk clear width below four feet. Street trees are also a common occurrence. While utility pole obstacles are less frequent, they are likely the most difficult and expensive fixed obstacle to remove from the sidewalk area.

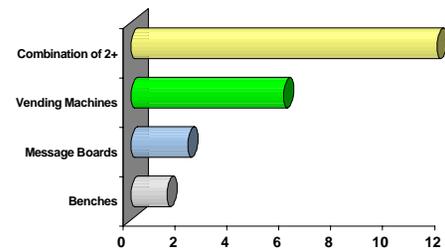
*Miles of Sidewalks with Movable Obstacles—Type*

variety of moveable obstacles were noted in the inventory, including benches with advertising boards, message boards (sometimes referred to as “sandwich” boards), vending machines and others. Sometimes street benches add to the pedestrian environment. Their placement, however, is critical to pedestrian mobility.

Along residential streets a variety of movable obstacles were identified in the inventory. Over 200 miles of existing sidewalks were noted as having some type of movable

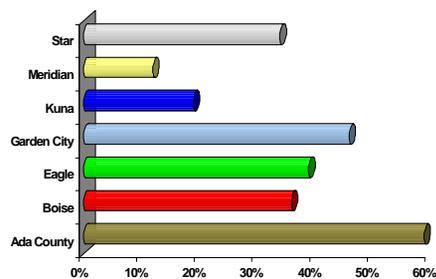
*Percent Streets Missing Sidewalks By Jurisdiction*

In general, and over the past 10-20 years, ACHD and the local jurisdictions have been ensuring that sidewalks are constructed on both sides of new streets. As a result, newer subdivisions have few missing sidewalks. A greater number of streets with missing sidewalks are located within older neighborhoods.

Both Meridian and Kuna have a much lower percentage of missing sidewalks than the county-wide average. Garden City has a much higher percentage than the average. Ada County, because much of the street system is located along undeveloped lands, also has a higher percentage of missing sidewalks. In addition, subdivisions in the unincorporated areas are typically larger-lot by design and are not required to construct sidewalks by County policy.

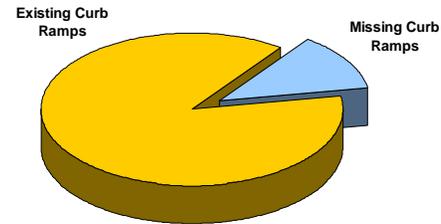
*Street Corners*

Of the more than 19,300 street corners inventoried along existing sidewalk corridors, only about 12 percent are missing curb ramps. All other corners have some type of curb ramp to assist the mobility-

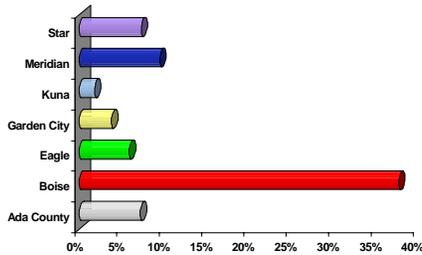
Percent Corners Missing Curb Ramps by Jurisdiction

Sidewalks with missing curb ramps are more often found in older neighborhoods. For example, a larger portion of Boise’s street and sidewalk system was constructed when curb ramp standards were not required. Also, a larger percentage of Boise’s network was developed along a grid street system with much short block lengths and a greater intersection density.

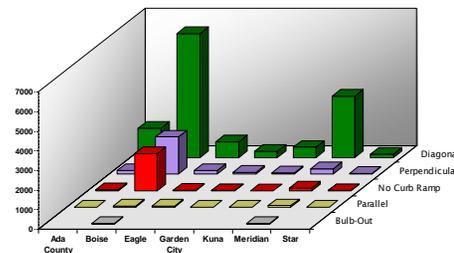
Curb Ramps by Type and Jurisdiction

study area are diagonal by design, with a single ramp oriented to the center of the street intersection. Perpendicular curb ramps are more often found in the older Boise neighborhoods where older sidewalks were constructed with sidewalk buffer strips. In recent growth areas, most new curb ramps have been constructed to standards with diagonal ramp designs, to align with curb-side sidewalks.

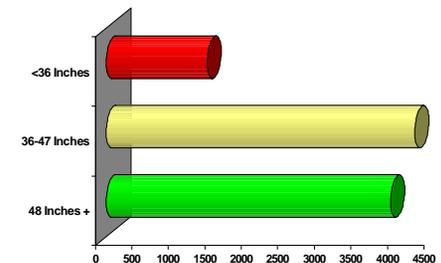
Curb Ramp Width

ADA requires that curb ramps be constructed with a minimum width of 3 feet and desired width of 4 feet. Many of the older curb ramps throughout the study area were built with widths well below 4 and sometimes 3 feet. Most of these ramps were constructed to design standards that preceded the ADA. However, they do meet the minimum design width as prescribed by ADA.

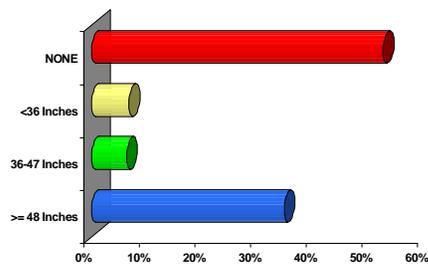
*Top Landing Width*

ADA requires that a top landing be placed at all curb ramps, four feet wide and a slope not to exceed 2 percent. Even new ramps, recently constructed to existing standards, include top landings, but with slopes that exceed the maximum of 2 percent (see *Local Design Guide*). Many of the system’s ramps are either missing the top landing, the ramp widths are too narrow, or the landing slope exceeds 2 percent.
